3-YEAR ASBESTOS RE-INSPECTION REPORT

JOHN ADAMS ELEMENTARY SCHOOL SCRANTON, PA

PROJECT: #SSD.19_751

July 2019

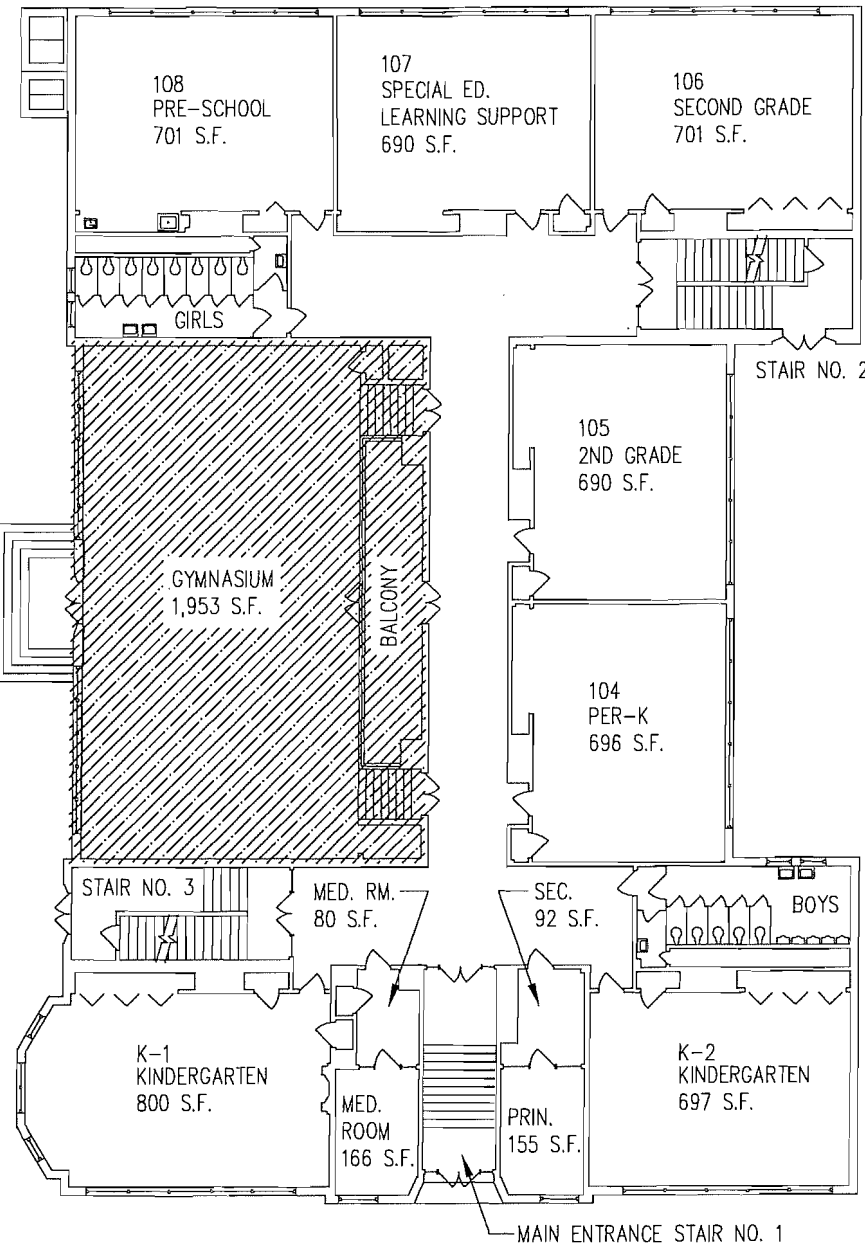
1ST FLOOR PLAN
NOT TO SCALE

ACOUSTICAL CEILING

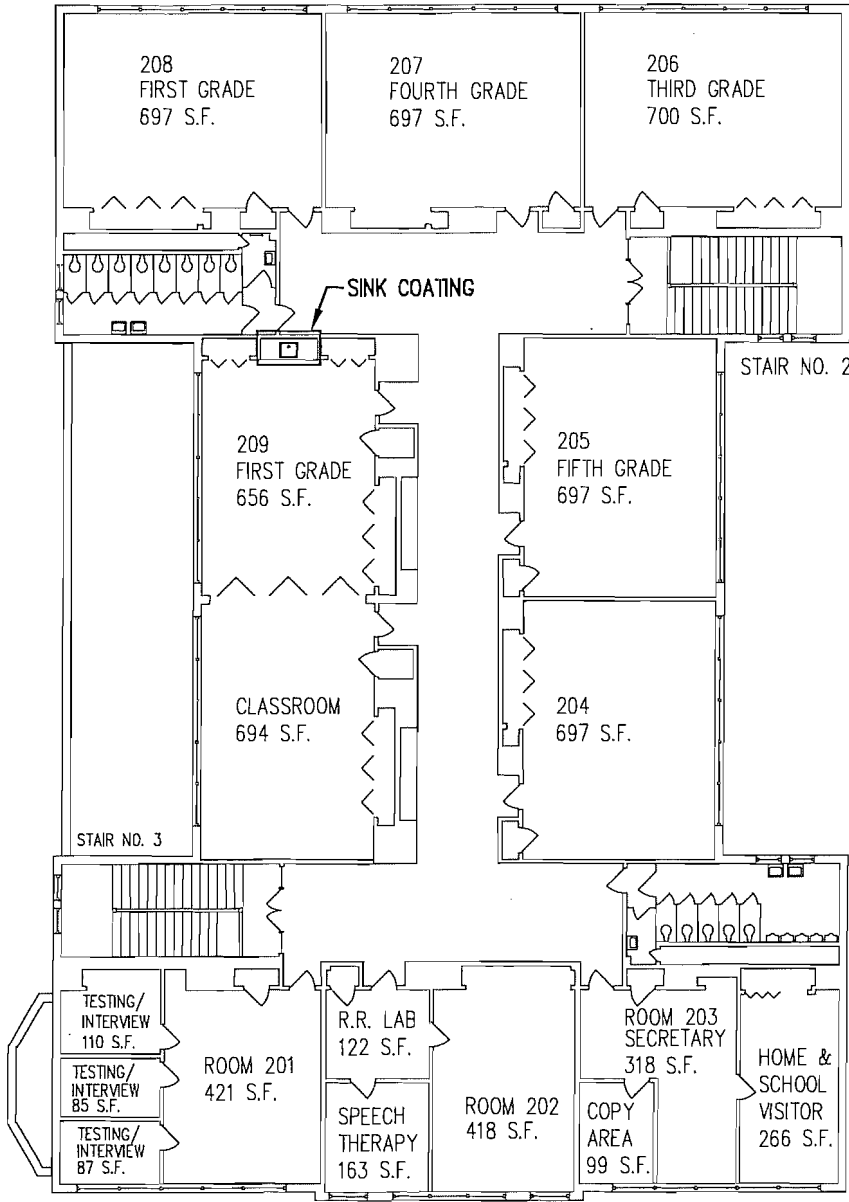
2ND FLOOR PLAN
NOT TO SCALE

ASSUMED ASBESTOS CONTAINING
SURFACING MATERIAL:
- EXTERIOR OF EXISTING SINK
IN ROOM 209

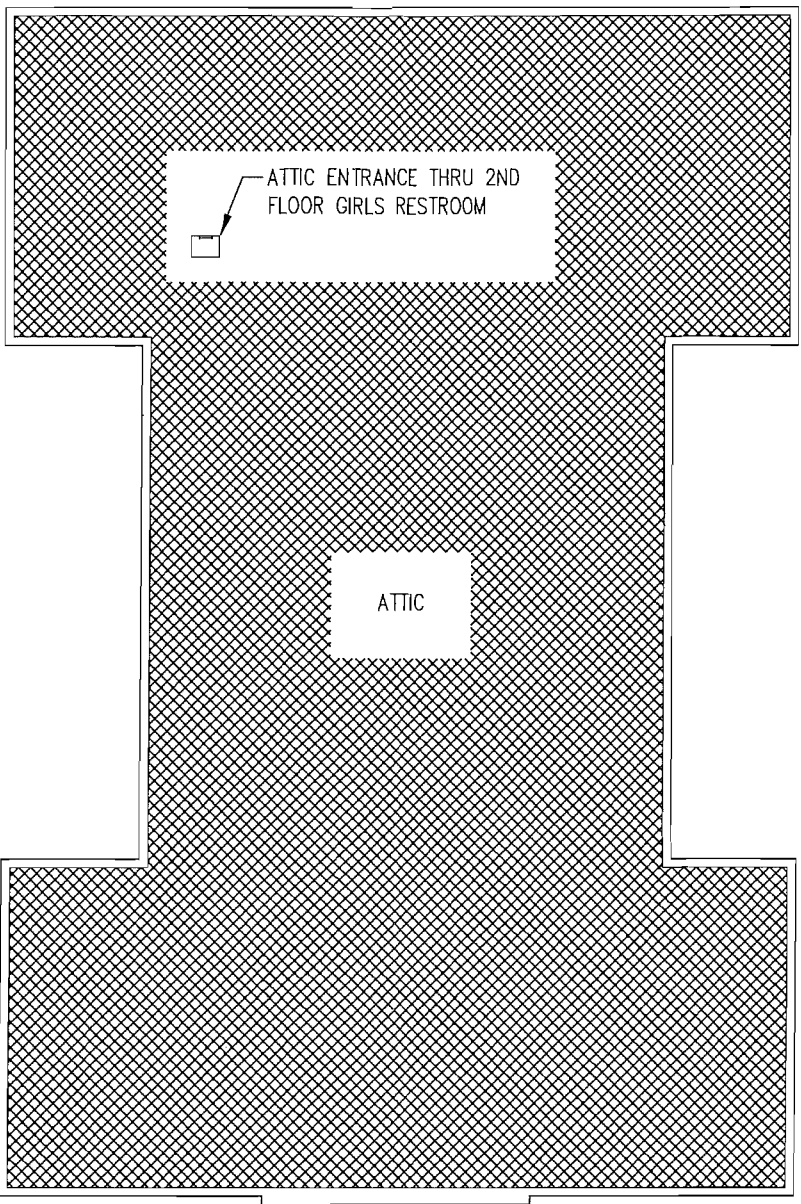
ATTIC FLOOR PLAN
NOT TO SCALE

CEMENTITIOUS FITTINGS
AND PIPE INSULATION
